Manhole Inspection Summary

Manhole # S27G__015MH

Insp Date: **5/23/08 8:24 AM**

Location Address: **1000 N Schroeder St**

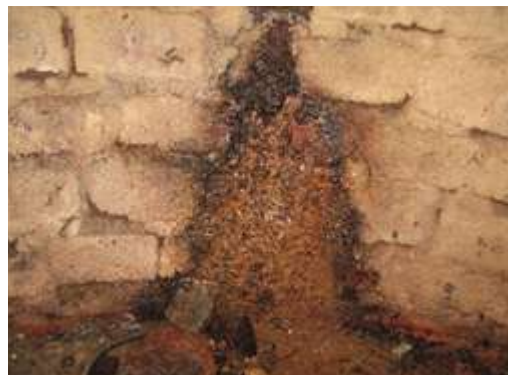
Defect 5

Infiltration: ☐ None ☐ Joint ☒ **Cracks** ☐ Mortar ☐ Roots ☒ **Wall**

barrel infiltration

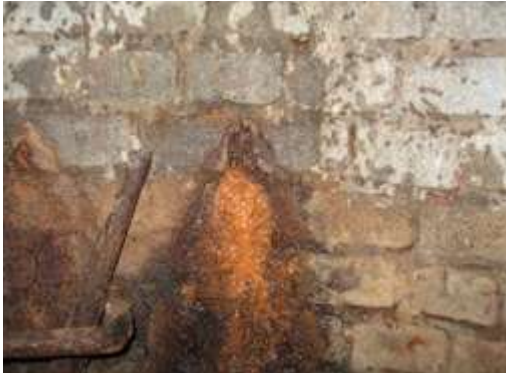
Defect 4

barrel infiltration

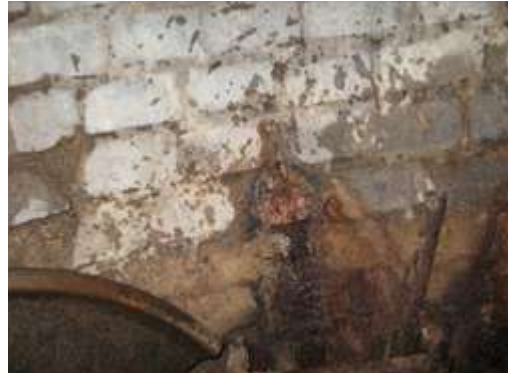
Defect 3

barrel infiltration

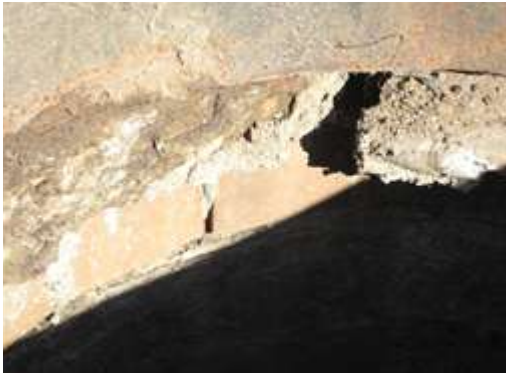
Defect 2

Condition: ☐ Sound ☒ **Cracked** ☐ Root Intrusion ☐ Loose Brick ☐ Deteriorated

loose brick chimney

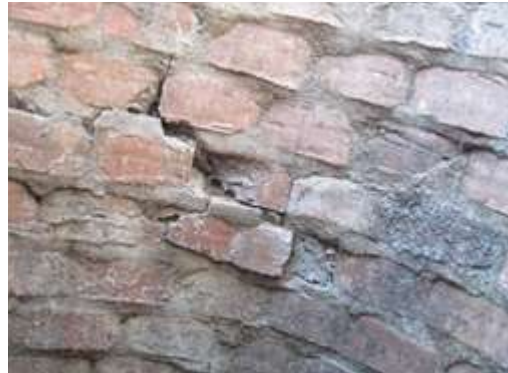
Defect 1

Condition: ☐ Sound ☒ **Cracked** ☐ Root Intrusion ☐ Loose Brick ☐ Deteriorated

cracked bricks corbel

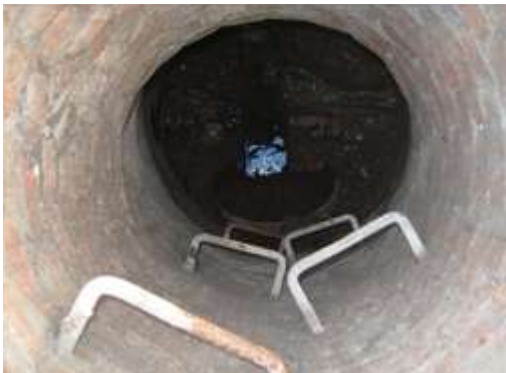
Defect 9

Count: **5** Missing: **0** ☒ **Corroded**

steps corroded

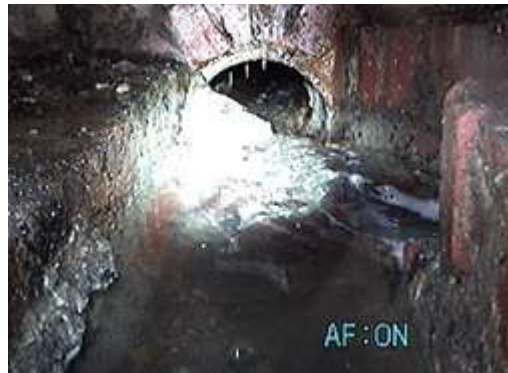
Defect 8

Condition: ☐ Sound ☐ Cracked ☐ Root Intrusion ☐ Deteriorated ☐ Leaks ☒ **Debris**

debris in channel

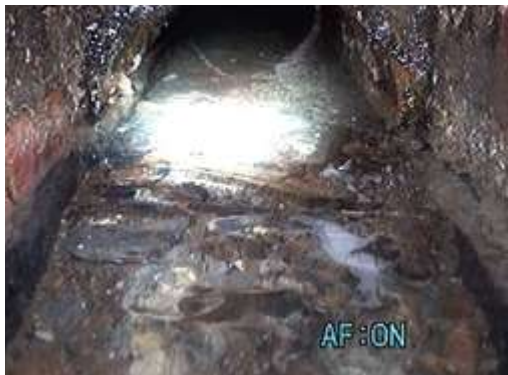
Defect 7

debri in channel

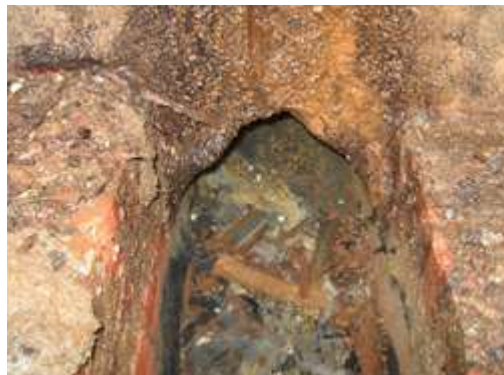
Defect 6

infiltration above 6 oclk pipe

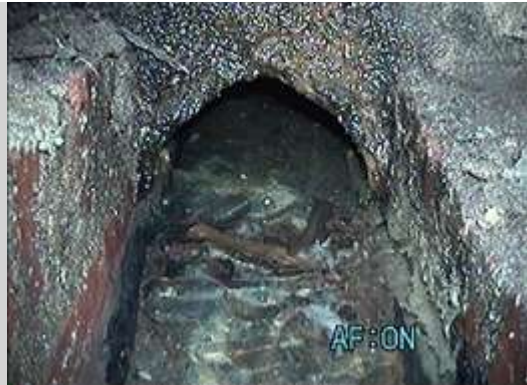
6 O'Clock Inflow

Deposits: ☐ None ☐ Mud ☐ Sludge ☒ **Debris** ☐ Grease

Silt Depth: **2** (in.) Deposits Extent: **Medium**
